## CSB-EPS-0283: Intermittent White/Black Lines Problem

Product Category:	Imagesetter	Product Name:	AV25S/30/44S
Document Author:	Gary Carlson	Date Published:	February 12, 1998
Document Number:	CSB-EPS-0283	Document Type:	Technical

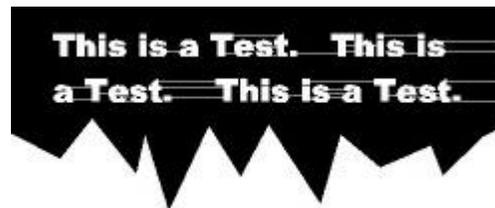
Figure -1

Over the last several months, intermittent white or black lines have appeared through images on certain Avantara models. The lines appear after a white/black transition and continue until the next transition. Refer to Figure 1 for an example of bad output. This problem has only appeared on systems that use the 4-DEC board (P/N 209714-50X). These systems include the Avantara 25S, 30 & 36S/44S.

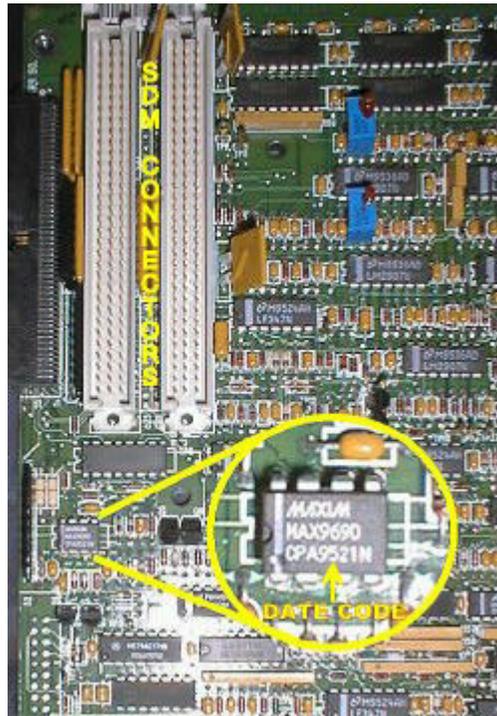
A timing problem has been found with one of the ECL Driver chips on the DEC board. The problem has been further isolated to a particular date code of that device (9521).

All 4-DEC boards in Manufacturing and Field Service stock will be checked for this bad date code and purged as necessary. Systems exhibiting the above mentioned problem in the field should be checked for this condition. Refer to Figure 2 for location of suspect driver chip (U2). If the IC has the bad date code, **9521**, replacement of the DEC board will be necessary.
